# MINUTEMAN HOME INSPECTIONS LLC

## RESIDENTIAL INSPECTION

1234 Main Street  
Berea, KY 40403

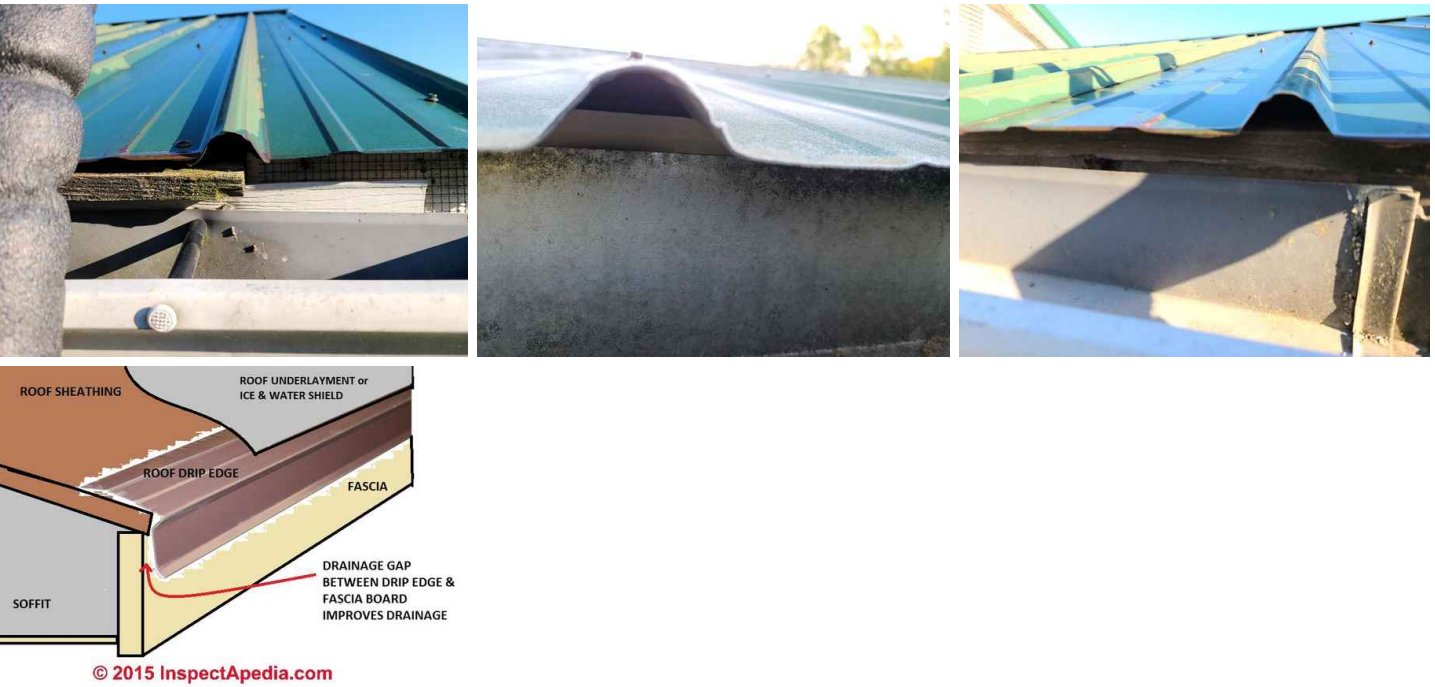
**DRIP EDGE FLASHING - MISSING/LOOSE**

**Drip edge flashing is loose and/or missing in one or more areas.** *This can allow water intrusion and deterioration of the roof decking.* Recommend further evaluation and repair as needed.

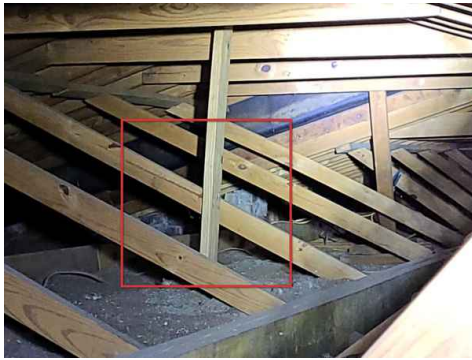
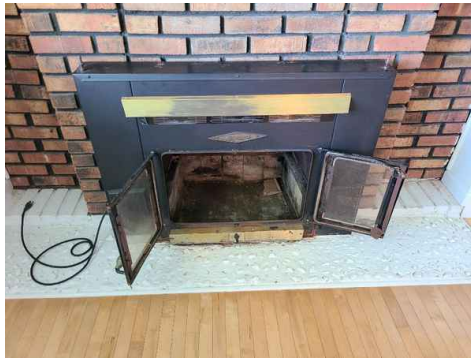
**CHIMNEY - DISMANTLED**

**Chimney was observed to be dismantled above the ceiling, rendering the fireplace insert inoperable.**  
*The portion of this fireplace below the ceiling was in tact. Recommend repairs as desired by a qualified masonry contractor.*

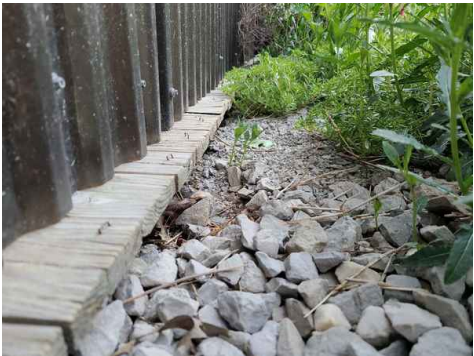
### DECK - LIMITED VISUAL

Limited visual inspection of the deck due to stored items, skirting, paneling, vegetation, or other visual obstructions.

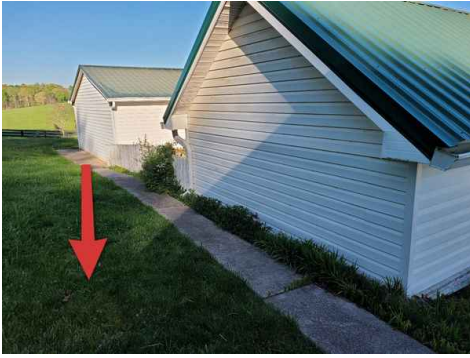
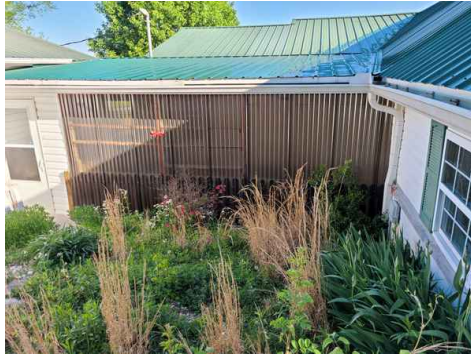
### 3.1.1 Grounds

**Grade is flat or *sloping towards the home* in one or more areas.** *The soil should slope away from the structure, with a 6" drop the first 10 feet.* This could lead to water intrusion and potential settlement if not addressed. Recommend a qualified landscaper or foundation contractor regrade so water flows away from home.

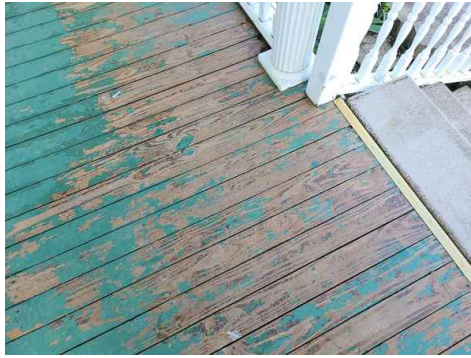
#### DECK - WEATHERED

The deck boards and/or framing shows signs of weathering, aging, and deterioration. Recommend further evaluation and repair by a qualified deck contractor.

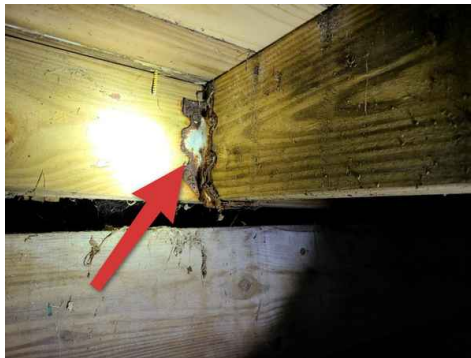
#### DECK - JOIST HANGERS

Joist hangers for the deck were missing, improperly installed, rusted, corroded, and/or have missing nails. See attached pictures & notes. Recommend further evaluation and repair by a qualified deck contractor.

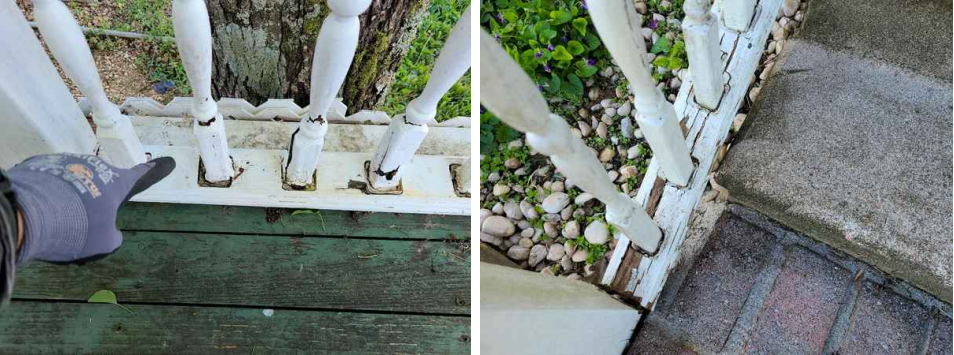
#### DECK - RAILING LOOSE/MISSING

**Deck has deteriorated, loose and/or missing railing in one or more areas** *which represents a safety concern.* Recommend repair as needed by a qualified contractor.

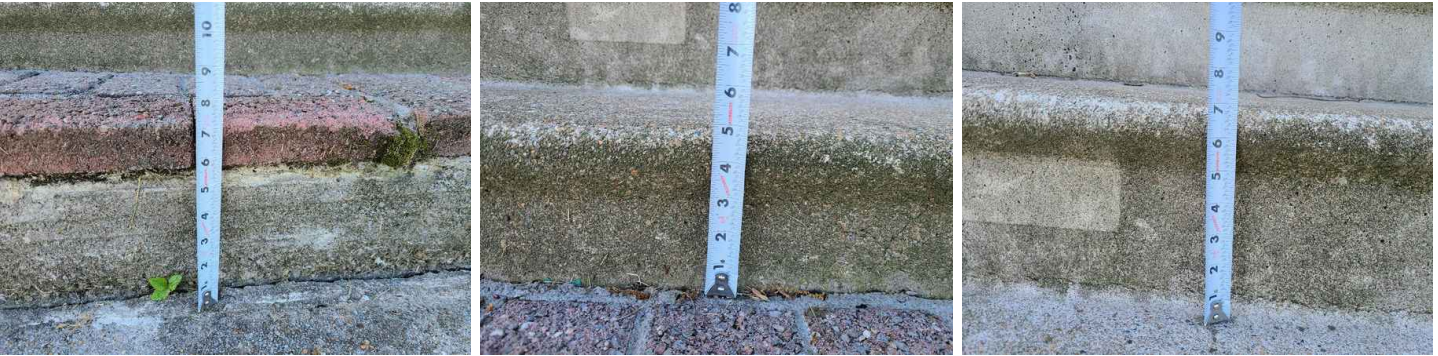
**STEP(S) - UNEVEN**

**Steps are uneven and/or have uneven risers.** *Treads and risers should be level, with a maximum slope of less than two degrees, and there can't be more than a 3/8-inch variation in tread/riser width throughout the entire staircase.* This could create a tripping hazard. Recommend repair by a qualified contractor.

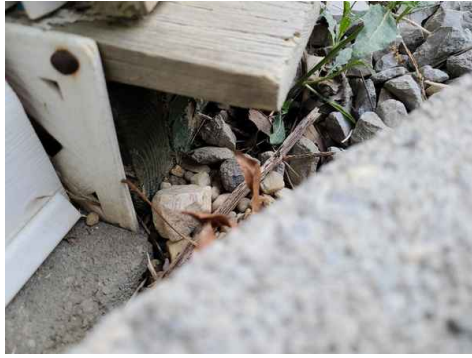
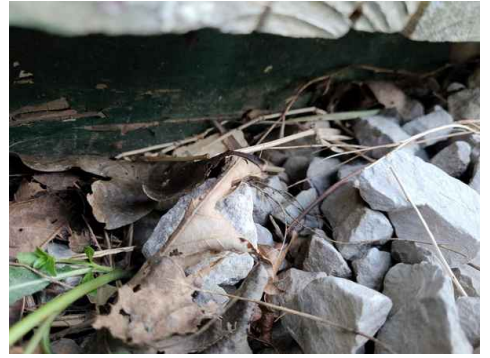
**WOOD - CONTACT WITH SOIL**

**Wood is in contact with ground** *which can facilitate wood rot/decay, and compromise the supporting structure.* Recommend repairing as needed by a qualified contractor.

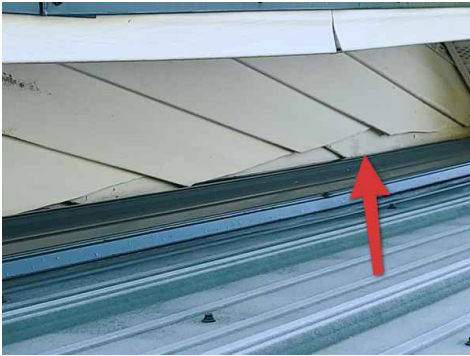
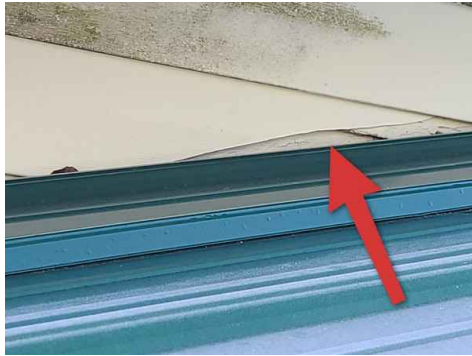
### 3.3.1 Siding, Flashing & Trim

#### VINYL SIDING - DEFECT(S)

**Vinyl siding was loose, missing, or damaged in one or more areas.** This can allow water intrusion and damage to the underlying structure. Recommend further evaluation and repair as needed.

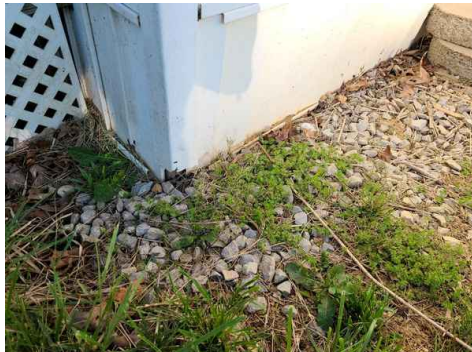
### 3.3.2 Siding, Flashing & Trim

#### SIDING - CLEARANCE FROM GROUND

**Siding is at or close to grade in one or more areas.** A gap of at least 6 inches should be provided. This gap helps to prevent siding deterioration, moisture intrusion, and pest entry. Recommend repair as needed.

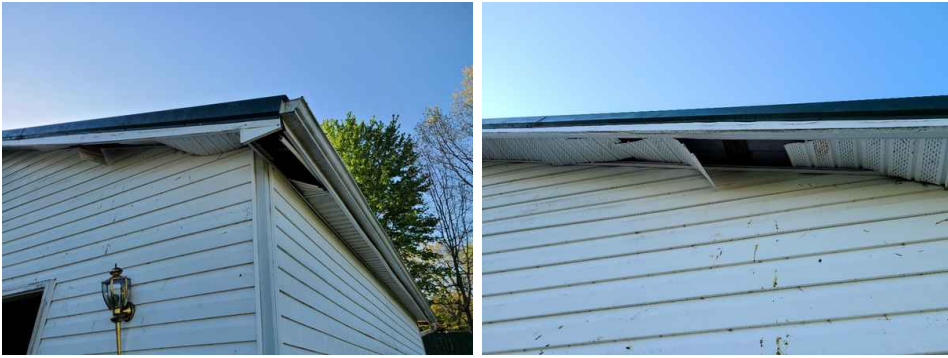
#### SOFFIT - DEFECTS

**Soffits were loose, missing, and/or damaged in one or more locations.** *This condition can facilitate water and pest intrusion. Recommend repairing as needed by a qualified contractor.*

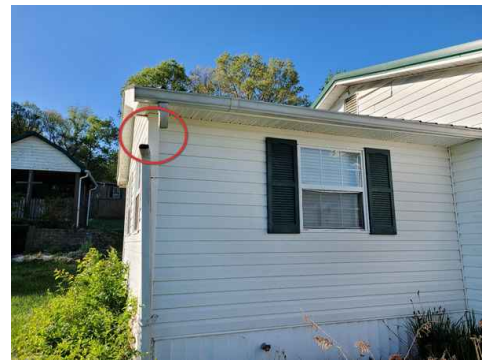
#### **DOWNSPOUT(S) - DEFECTS**

**One or more downspouts are missing, loose, damaged, and/or misaligned.** *This can result in excessive moisture in the soil at the foundation, which can lead to foundation/structural movement. Recommend a qualified contractor repair as needed.*

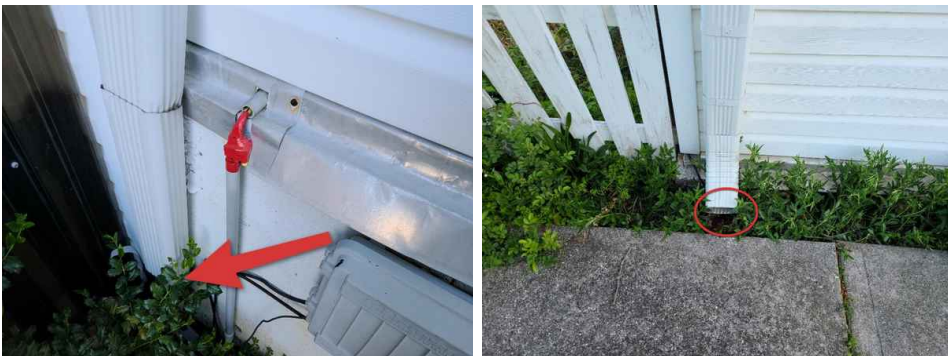
#### **DOWNSPOUTS - DRAIN NEAR STRUCTURE**

**One or more downspouts drain too close to the foundation.** *This can result in excessive moisture in the soil at the foundation, which can lead to foundation/structural movement. Recommend a qualified contractor adjust downspout extensions to drain at least 6 feet from the foundation.*

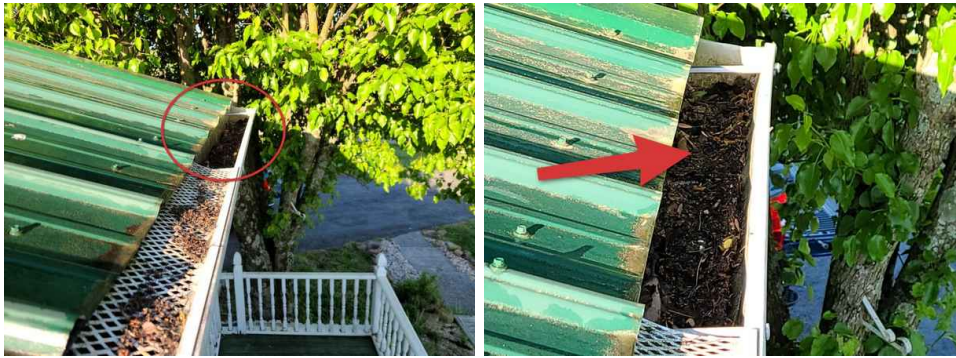
#### **GUTTER - SCREEN DEFECT**

**Gutter screen is loose, missing and/or damaged in one or more areas.** *This can result in clogged and/or damage to gutter and wood fascia board. Eventually resulting in excessive moisture in the soil at the foundation, which can lead to foundation/structural movement. Please see attached pictures. Recommend repair as needed by a qualified contractor.*

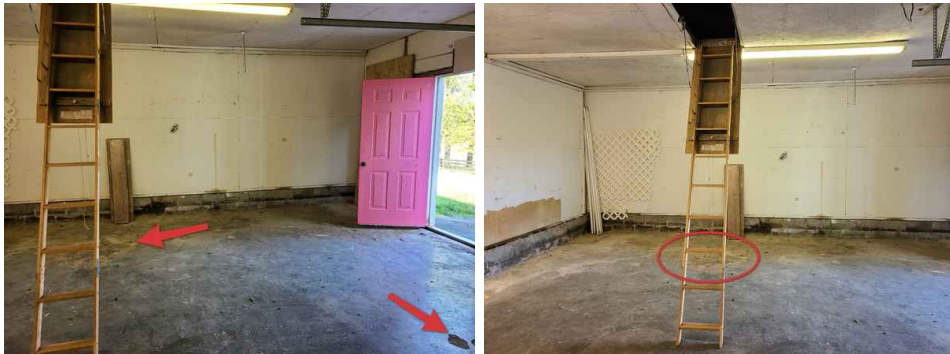
#### FLOOR - TYPICAL CRACKING/SETTLEMENT/SPALLING

**Garage floor has typical cracking, minor settlement and/or spalling.** *Recommend monitoring and repair as needed by a qualified contractor.*

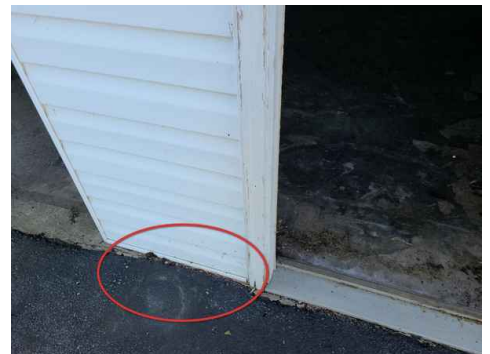
#### 4.2.2 Ceiling, Floor, Walls & Occupant Door

**Garage wall and/or ceiling showed signs of moisture intrusion.** *This can facilitate fungal growth and attract wood destroying insects. Recommend a qualified contractor evaluate & repair as needed.*

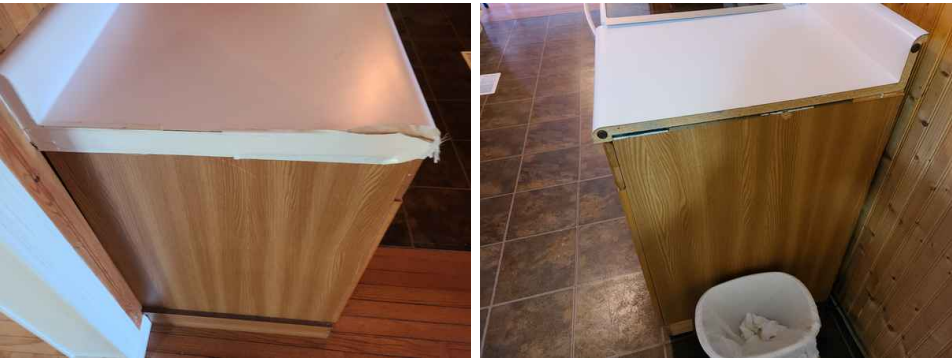
A countertop was loose and/or damaged at time of inspection. Recommend repair as needed by a qualified contractor.

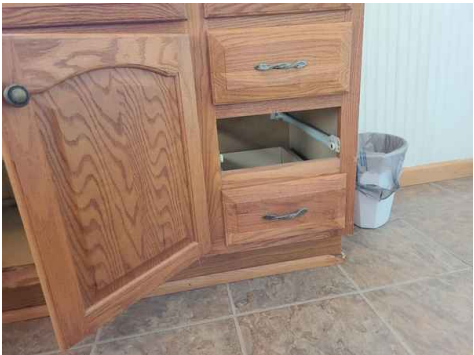
DRAWER - LOOSE/MISSING/DAMAGED

One or more drawers is loose, missing, or damaged at this time. Recommend repair as needed by a qualified contractor.

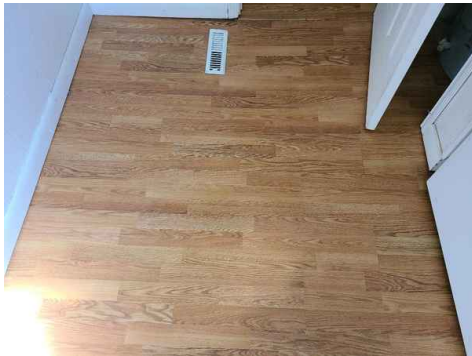
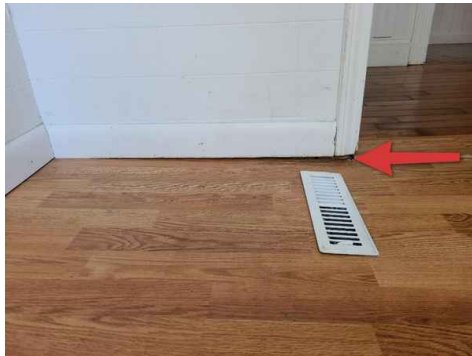
**The floor(s) were settled, sunken, and/or sloping in one or more areas.** This could indicate prior or ongoing settlement, framing and/or floor installation deficiencies. Recommend further evaluation and repairing as needed by a qualified contractor.

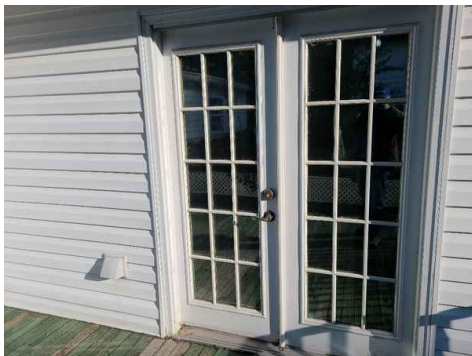
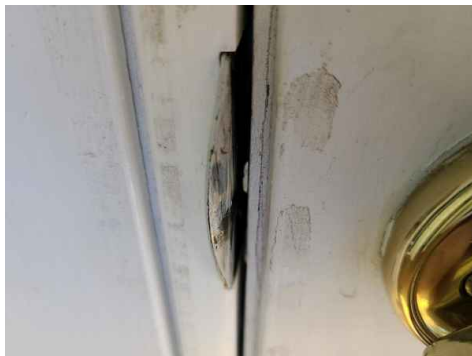
### 5.3.1 Doors

#### DOOR(S) - ADJUSTMENT NEEDED

**A door(s) fails to shut or latch properly.** Recommend repair as needed by a qualified contractor.

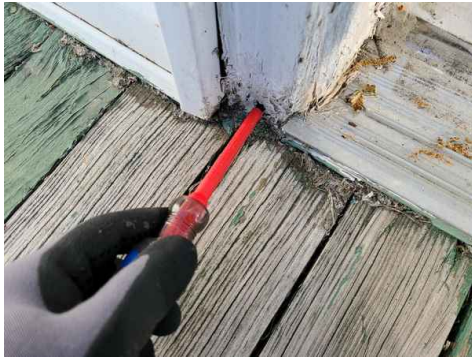
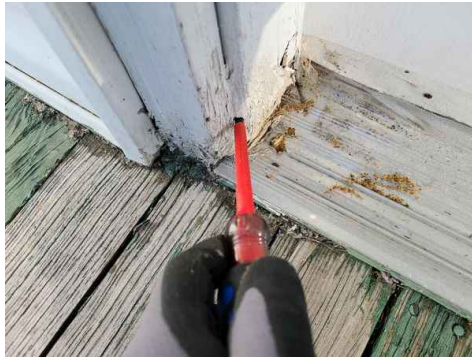
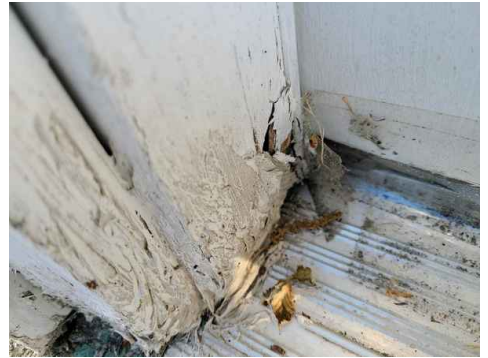
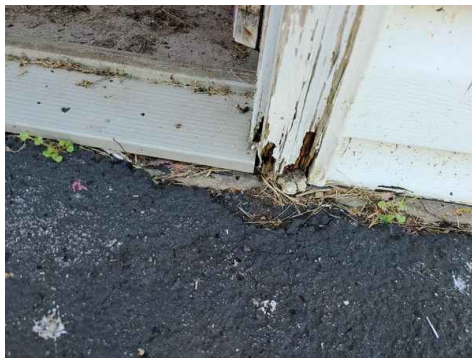
**Door(s), frame, and/or hardware has damage or deterioration.** *This can decrease the energy efficiency of the home, allow water and pest intrusion, and potential damage to the underlying structure. Recommend repair as needed by a qualified contractor.*

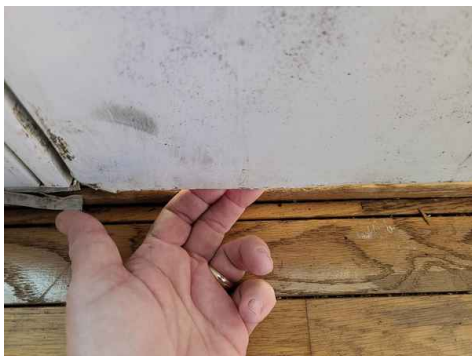
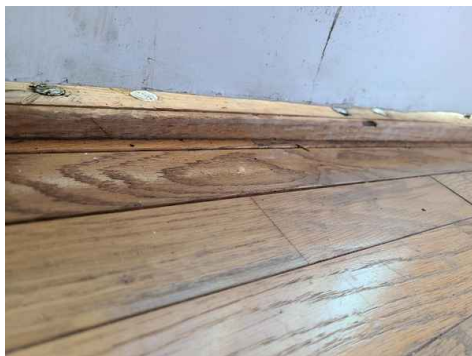
**Door(s), frame, and/or hardware has damage or deterioration.** Recommend repair by a qualified contractor.

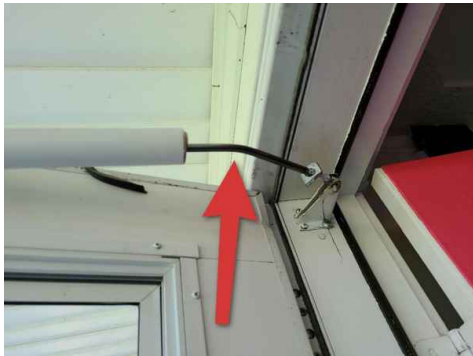
**Storm door has a failed, missing, or improperly adjusted closer.** Recommend repair as needed by a handyman.

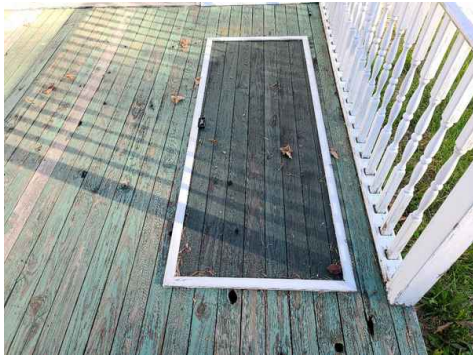
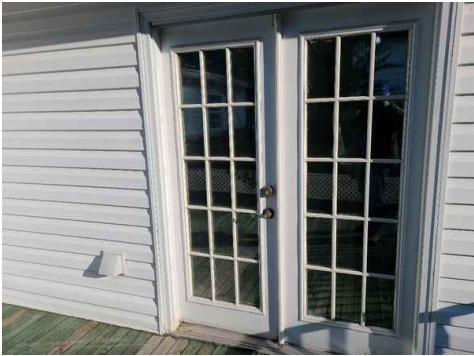
SCREEN DOOR - DEFECT(S)

Sliding screen door is loose, missing, or damaged at this time. Recommend repair by a qualified contractor.

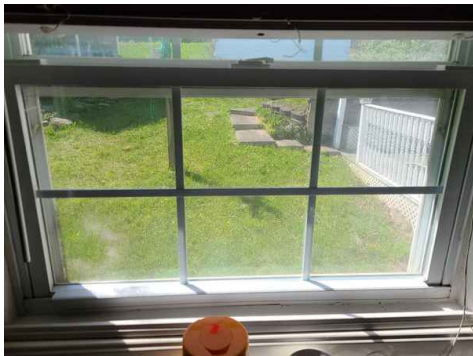
WINDOW - SASH FALLING

One or more windows fail to stay up under its weight. *This is likely due to a broken window balance. Window balances are spring-loaded mechanisms that can be found on either side of the window frame. Their job is to regulate the opening and closing of the window sash.* Recommend further evaluation and repair as needed.

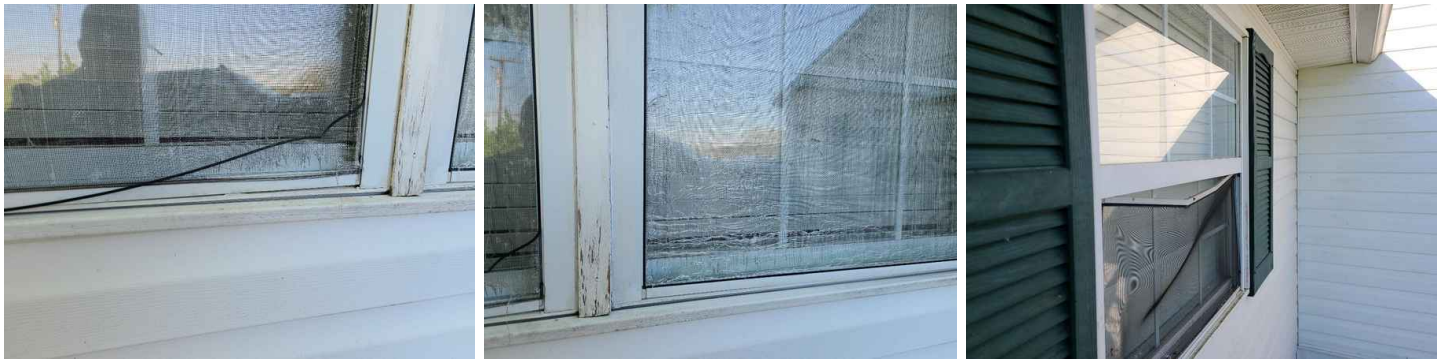
WINDOW - SCREENS MISSING/DAMAGED

Missing or damaged window screens were observed in one or more locations. Recommend repairing as needed.

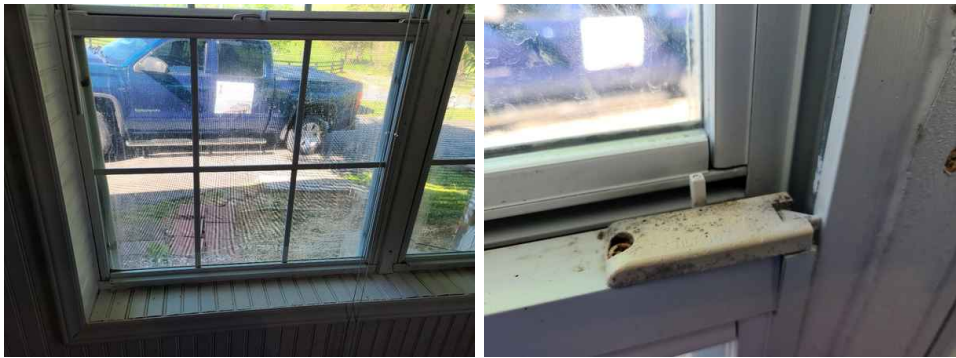
One or more windows failed to open at this time. Recommend further evaluation and repair by a qualified contractor.

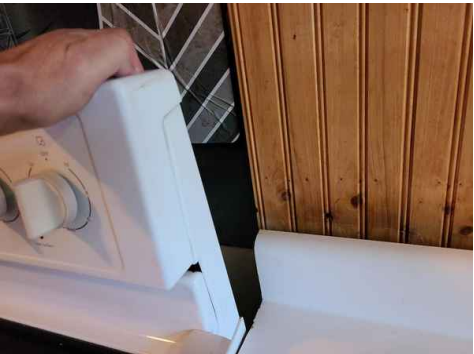
Range/Oven was not equipped with an anti-tip bracket, fastened to the floor. *This poses a safety hazard to children.* Recommend a qualified contractor secure range so it can't tip.

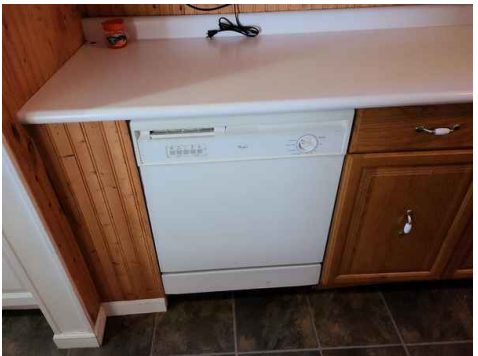
Dishwasher was inoperable at time of inspection using standard controls. *This could be due to the water supply valve, or power being turned off.* Recommend a qualified plumber or contractor evaluate and repair as needed.

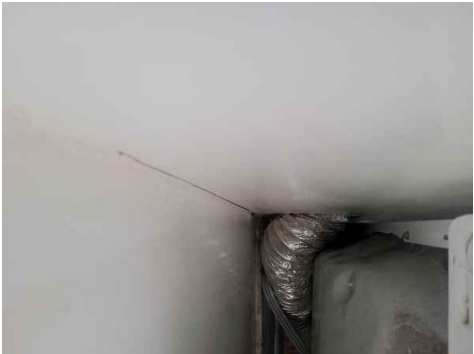
**Dryer vent was damaged at this time.** *Recommend repair as needed by a handyman or qualified contractor.*

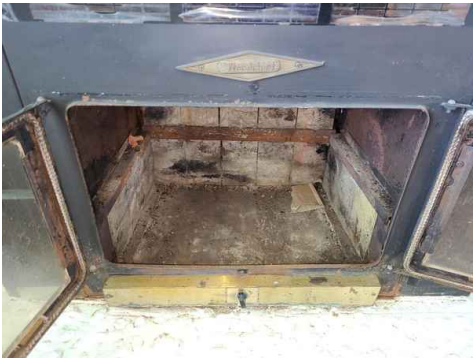
The firebox was cracked, damaged, and/or deteriorated in one or more places, which could lead to chimney damage or toxic fumes entering the home. Recommend a qualified fireplace contractor evaluate and repair.

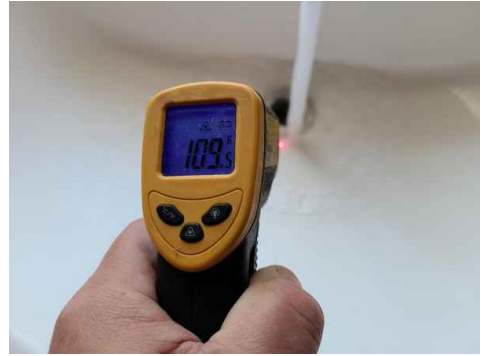
**Anything below 120 degrees creates a risk for bacteria to develop inside your water heater from stagnant water, such as legionella that causes Legionnaire's disease. By setting it above 120 degrees, the water will be too hot for bacteria to grow. Recommend adjusting the temperature at the control as needed.**

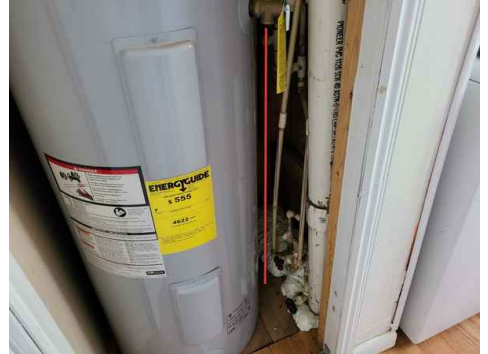
**TPR VALVE - PIPING**

**A temperature pressure relief valve (TPR) should have a discharge pipe that extends to within 6 inches of the floor to prevent scalding if the valve discharges overheated water.**

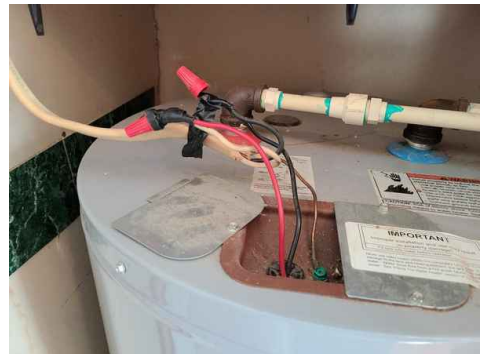
**WATER HEATER - WIRING**

**Wiring for the water heater is exposed, not secured and/or has a loose connector. Recommend repair by a licensed electrician.**

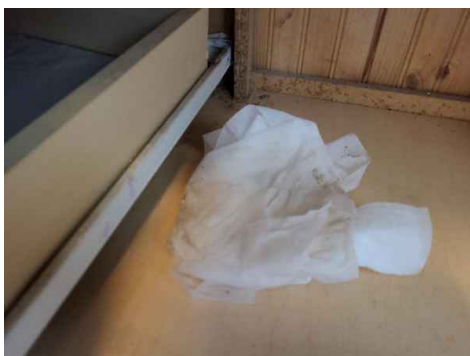
**Active plumbing leak(s) observed in one or more areas. Trapped water behind floors, walls, and/or ceilings can be conducive to biogrowth and damage underlying structure. Recommend further evaluation and repair as needed by a licensed plumber.**

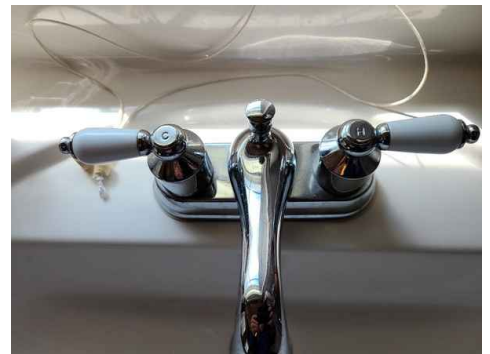
**MIXING VALVE - REVERSED**

***Tub or shower hot/cold mixing valve was reversed but functional at this time. Repair may be desired.***

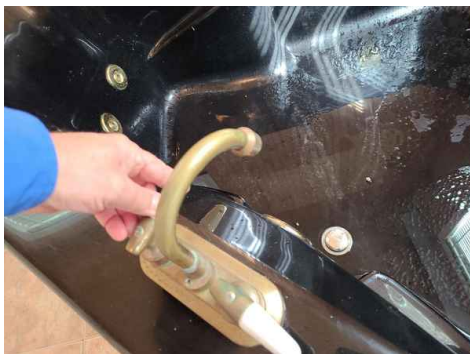
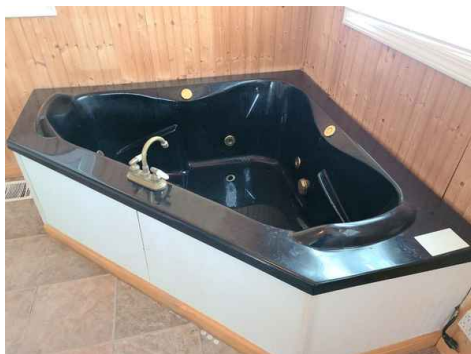
**One or more tub/showers were inoperable at this time. Recommend repair as needed by a licensed plumber.**

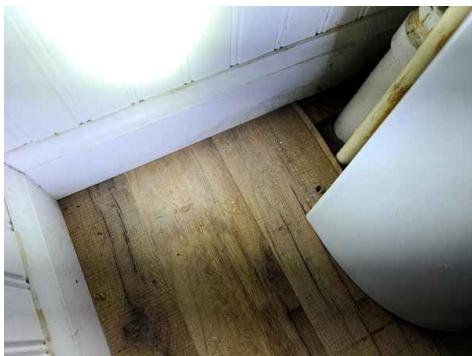
**An active leak(s) was observed.** *The leak was verified visually, or a moisture meter read above the recommended dry range of 14%.* Recommend repair as needed by a licensed plumber.

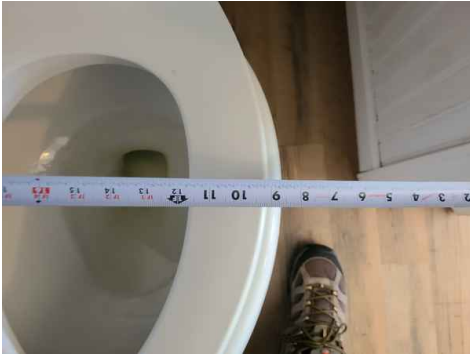
## 8.4.3 Faucets, Sinks, &amp; Toilets

**TOILET - CLEARANCE**

**Inadequate toilet clearance was observed.** *There should be a minimum of 15 inches clearance to the center of the bowl on both sides.* Recommend repairs by a licensed Plumber.

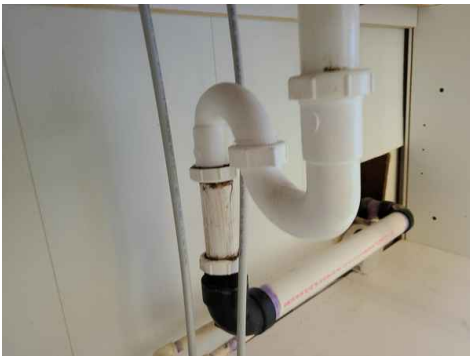
#### 8.4.4 Faucets, Sinks, & Toilets

##### **SINK - S TRAP**

**A "S" trap was observed in one or more locations.** A "S" trap will siphon or suck water out from the trap which will end up releasing methane (sewer) gases into the home. Recommend further evaluation and repair by a licensed plumber.

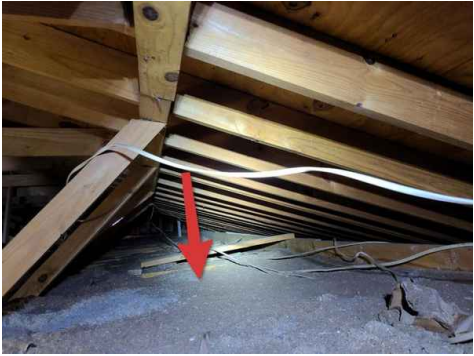
**Insulation depth appeared to be inadequate and/or not evenly distributed.** *This can reduce the thermal efficiency of your home. The recommended level for most attics is to insulate to R-38 or about 10 to 14 inches, depending on insulation type. Recommend further evaluation and repair by a qualified attic insulation contractor*

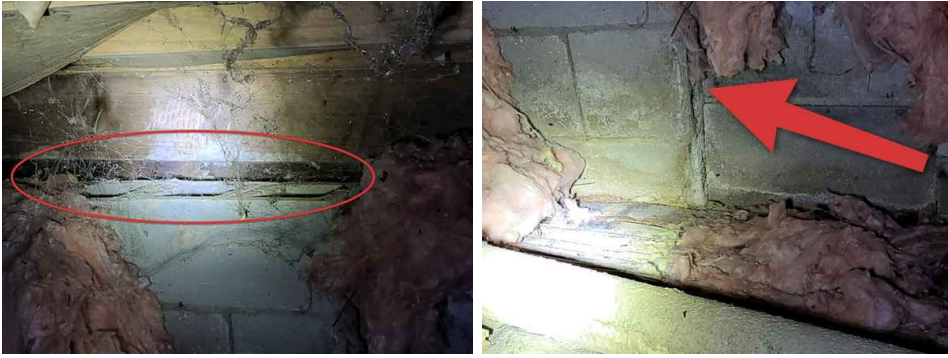
9.2.1 Exterior Foundation

**Foundation movement was observed in one or more areas.** *This could be from poorly compacted soils, poor drainage, or from previous or ongoing settlement. Recommend further evaluation and repair as needed by a foundation contractor.*

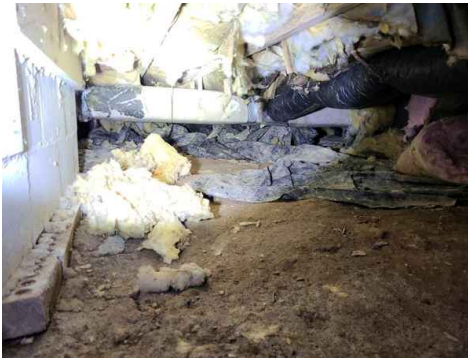
### Proper Crawlspace Vapor Barrier

**Vapor barrier was observed to be damaged in areas and missing in other areas in the crawlspace.** *A vapor barrier is recommended to cover the soil as several gallons of water may evaporate from the earth/soil daily, adding moisture, humidity, and condensation to the crawl space area. This can lead to the formation of fungal growth on framing components and other moisture related deficiencies. The installation of a minimum of a 6 mil poly vapor barrier is recommended to be conducted by a qualified contractor.*

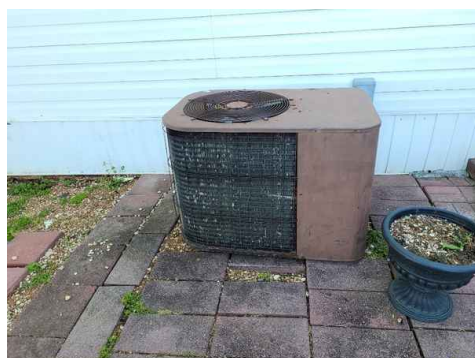
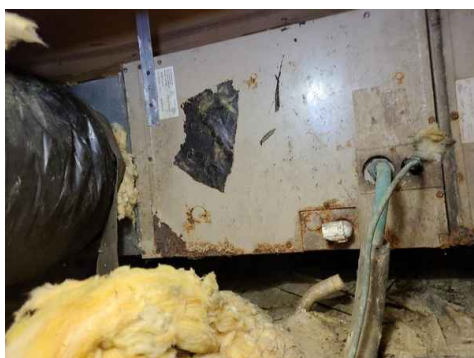
**The cooling system is at or near the 15-20 year predicted life expectancy for our region. You should have it serviced and budget to replace it at any time. Recommend further evaluation and repair as needed by a licensed HVAC technician.**

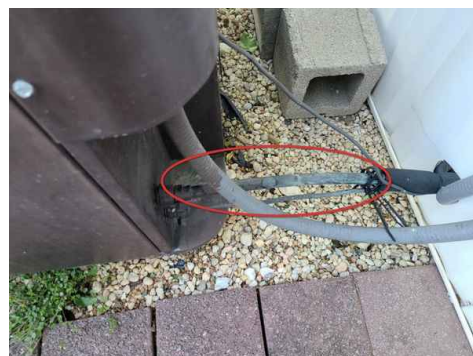
**A/C UNIT - INSULATION DEFECT(S)**

**Missing, damaged, or deteriorated insulation on the refrigerant line was observed. This can cause energy loss and condensation. Recommend repair as needed by a handyman or HVAC contractor.**

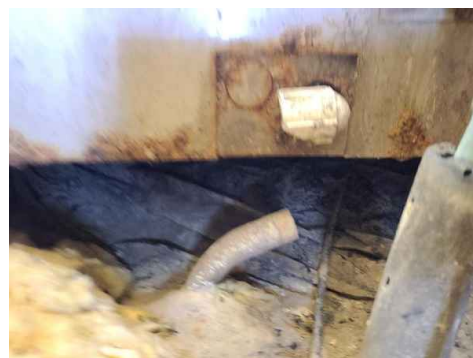
**CONDENSATE LINE - DAMAGED**

**Condensate tube was damaged, which limits safe discharge of condensation produced by evaporator coils. Recommend a qualified HVAC technician repair.**

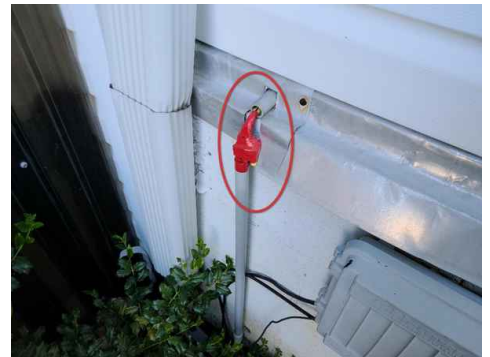
Moderate Defect

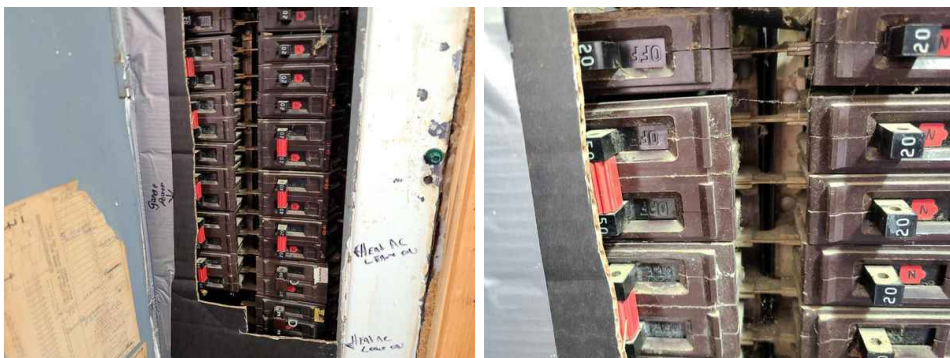
#### PANEL - KNOCKOUT PLATE MISSING

Moderate Defect

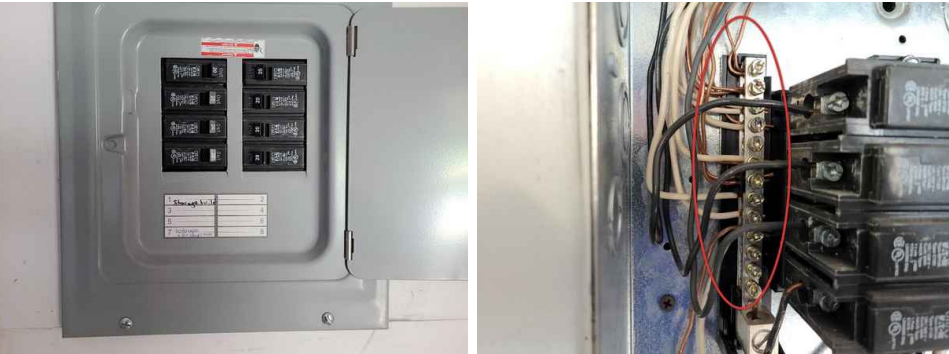
**Subpanel had grounds/neutrals that weren't separated.** *This condition allows current multiple paths back to the main panel and can present a shock hazard. Recommend repair by a licensed electrician.*

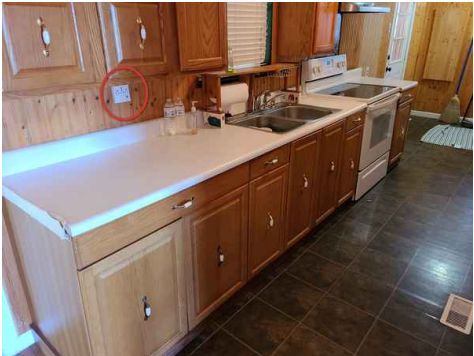
**Lack of GFCI protection was observed within 6' of a water source.** *GFCI outlets are ideally used to prevent electrical shock and damage when water comes in contact with the outlet. Recommend upgrading as needed by a licensed electrician.*

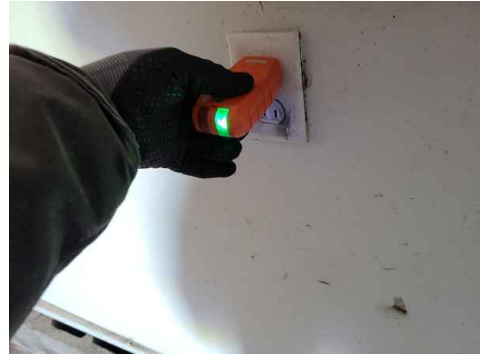
## 11.2.3 Lighting Fixtures, Switches &amp; Receptacles

**Lack of GFCI protection was observed within 6' of a water source.** *GFCI outlets are ideally used to prevent electrical shock and damage when water comes in contact with the outlet.* Recommend upgrading as needed by a licensed electrician.

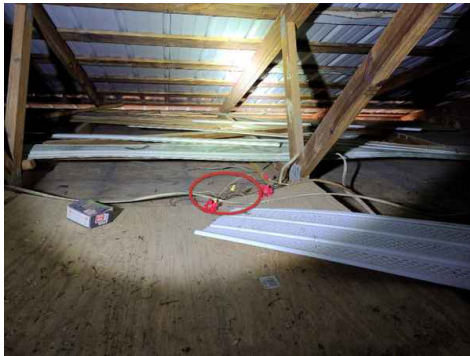
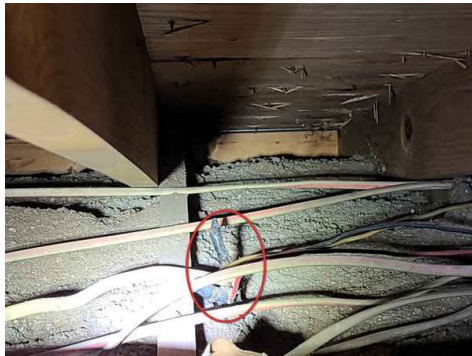
**WIRING - EXPOSED**

**Wiring is exposed that is not properly protected.** *Exposed wiring can easily be damaged and presents a shock hazard. Splices are required to be contained in an approved junction boxes. Junction boxes should have the appropriate cover installed. Please refer to the pictures for any additional notes and/or details.* Recommend a licensed electrician for further evaluation and repair.

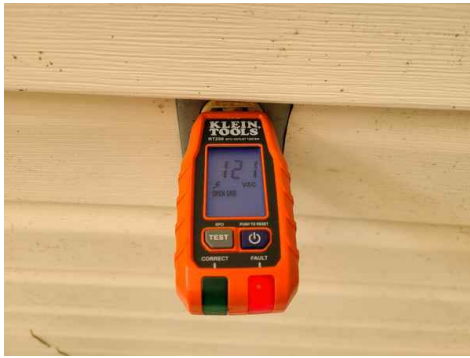
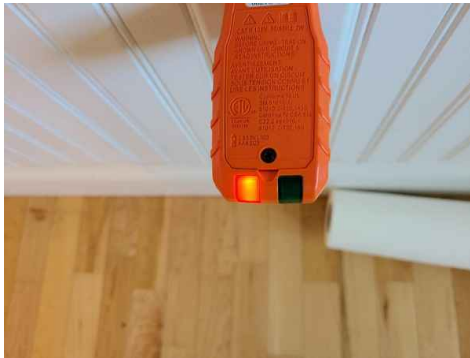
**OUTLETS - OPEN GROUND**

**One or more outlets had an open ground at this time.** *This is likely due to a loose connection at the outlet or panel.* Recommend repair as needed by a licensed electrician.

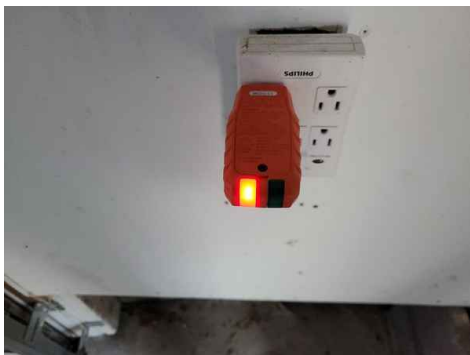
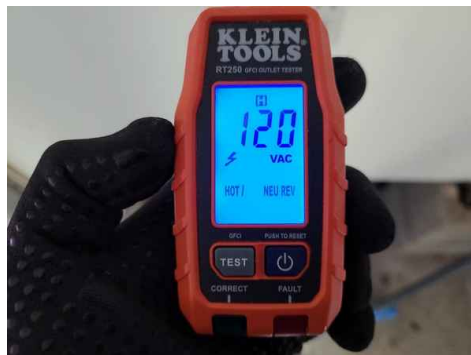
#### 11.2.6 Lighting Fixtures, Switches & Receptacles

### OUTLET(S) - REVERSED POLARITY

**One or more receptacles have been wired with reversed polarity.** *This can impose a shock hazard.*  
Recommend licensed electrician evaluate & repair.
